**U.S. Department of Transportation  
Federal Aviation Administration**

**Airworthiness Directive  
Revision**

79-11-05 R1 MOONEY: Amendment 39-3480 as amended by Amendment 39-4050. Applies to Mooney M-18L S/N's 2 and up, M-18C S/N's 201 and up, M-18LA S/N's 100 through 200, M-18C55 S/N's 323 and up certificated in all categories.

## COMPLIANCE OF AD79-11-05R1 FOR MOONEY MITES

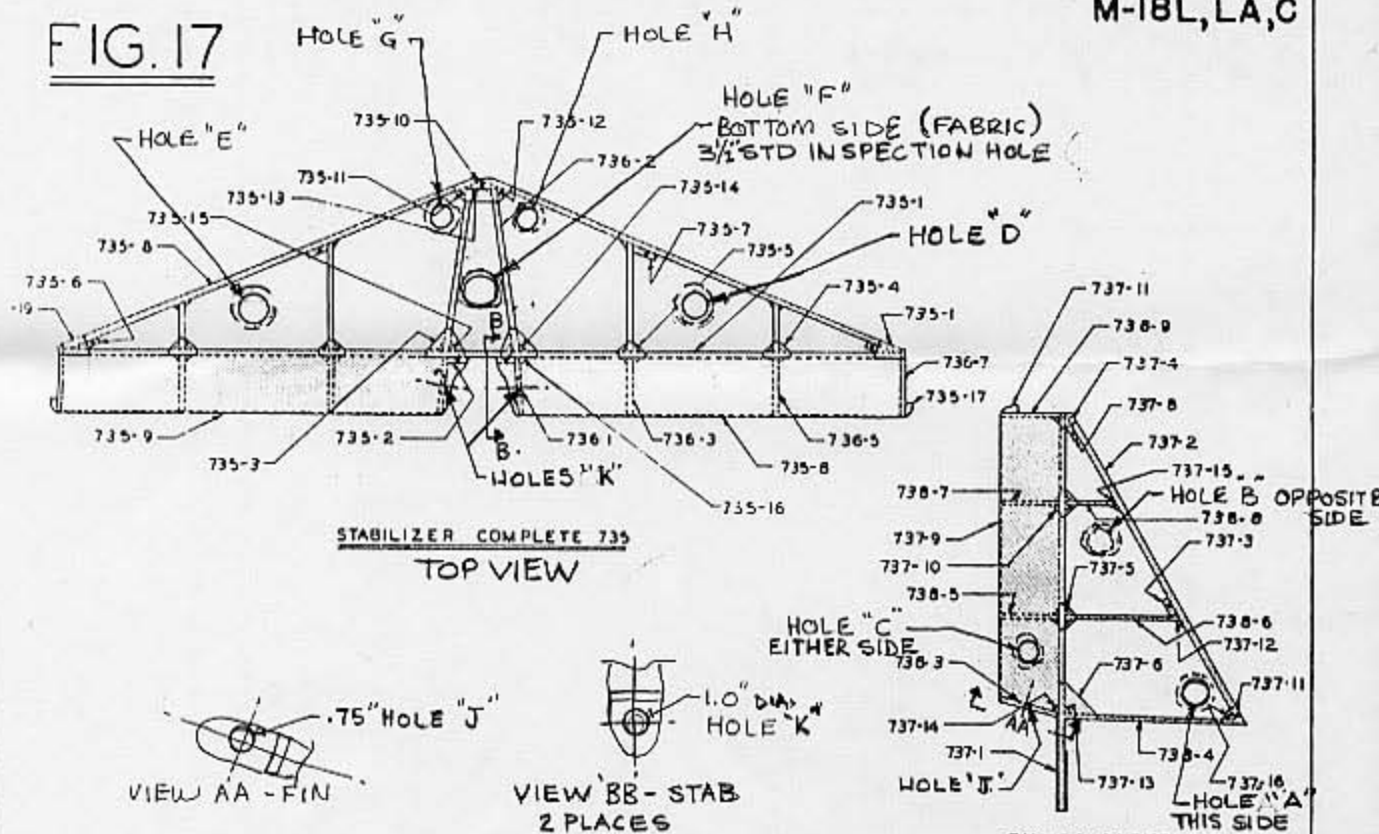
FIG. 17

- (2) At center junction of stabilizer spar and fin inspect glue joint between attach blocks and stabilizer spar for deterioration and inspect spar and blocks for cracks. Inspect fin and spar for cracks at attachment bolts.

- (3) Inspect rear bulkhead of the stabilizer for cracks and looseness in the area of the stabilizer attachments. Inspect attachment blocks for cracks or looseness at spar.

- (a) Cut 2.00 inch diameter holes in approximately the locations as shown on stab & fin drawing.
- (b) Cut a 2.62 inch diameter plastic ring with a 2.00 inch diameter hole from a .025 inch thickness material.

- (e) Follow the procedures (b) through (d) above for holes "A" through "H", except for hole "F". All holes in stabilizer are located on bottom side only.

- (f) The holes shown in view AA and BB should remain open. If hole "K" is to be used for inspection purposes, hole "C" is not required or vice versa; it's optional.

- (g) NOTE: Hole "F" is already an existing inspection hole in the bottom side of stabilizer.
- (h) Holes in fin are placed on either side or as noted on the drawing.

- C. In order to accomplish the stab & fin modifications of inspection holes to accommodate the AD note, the stab & fin assembly should be removed from the fuselage. In addition, it is best to disassemble the stab & fin for access to cut certain inspection holes for inspection of possible spar cracks and wood deterioration.

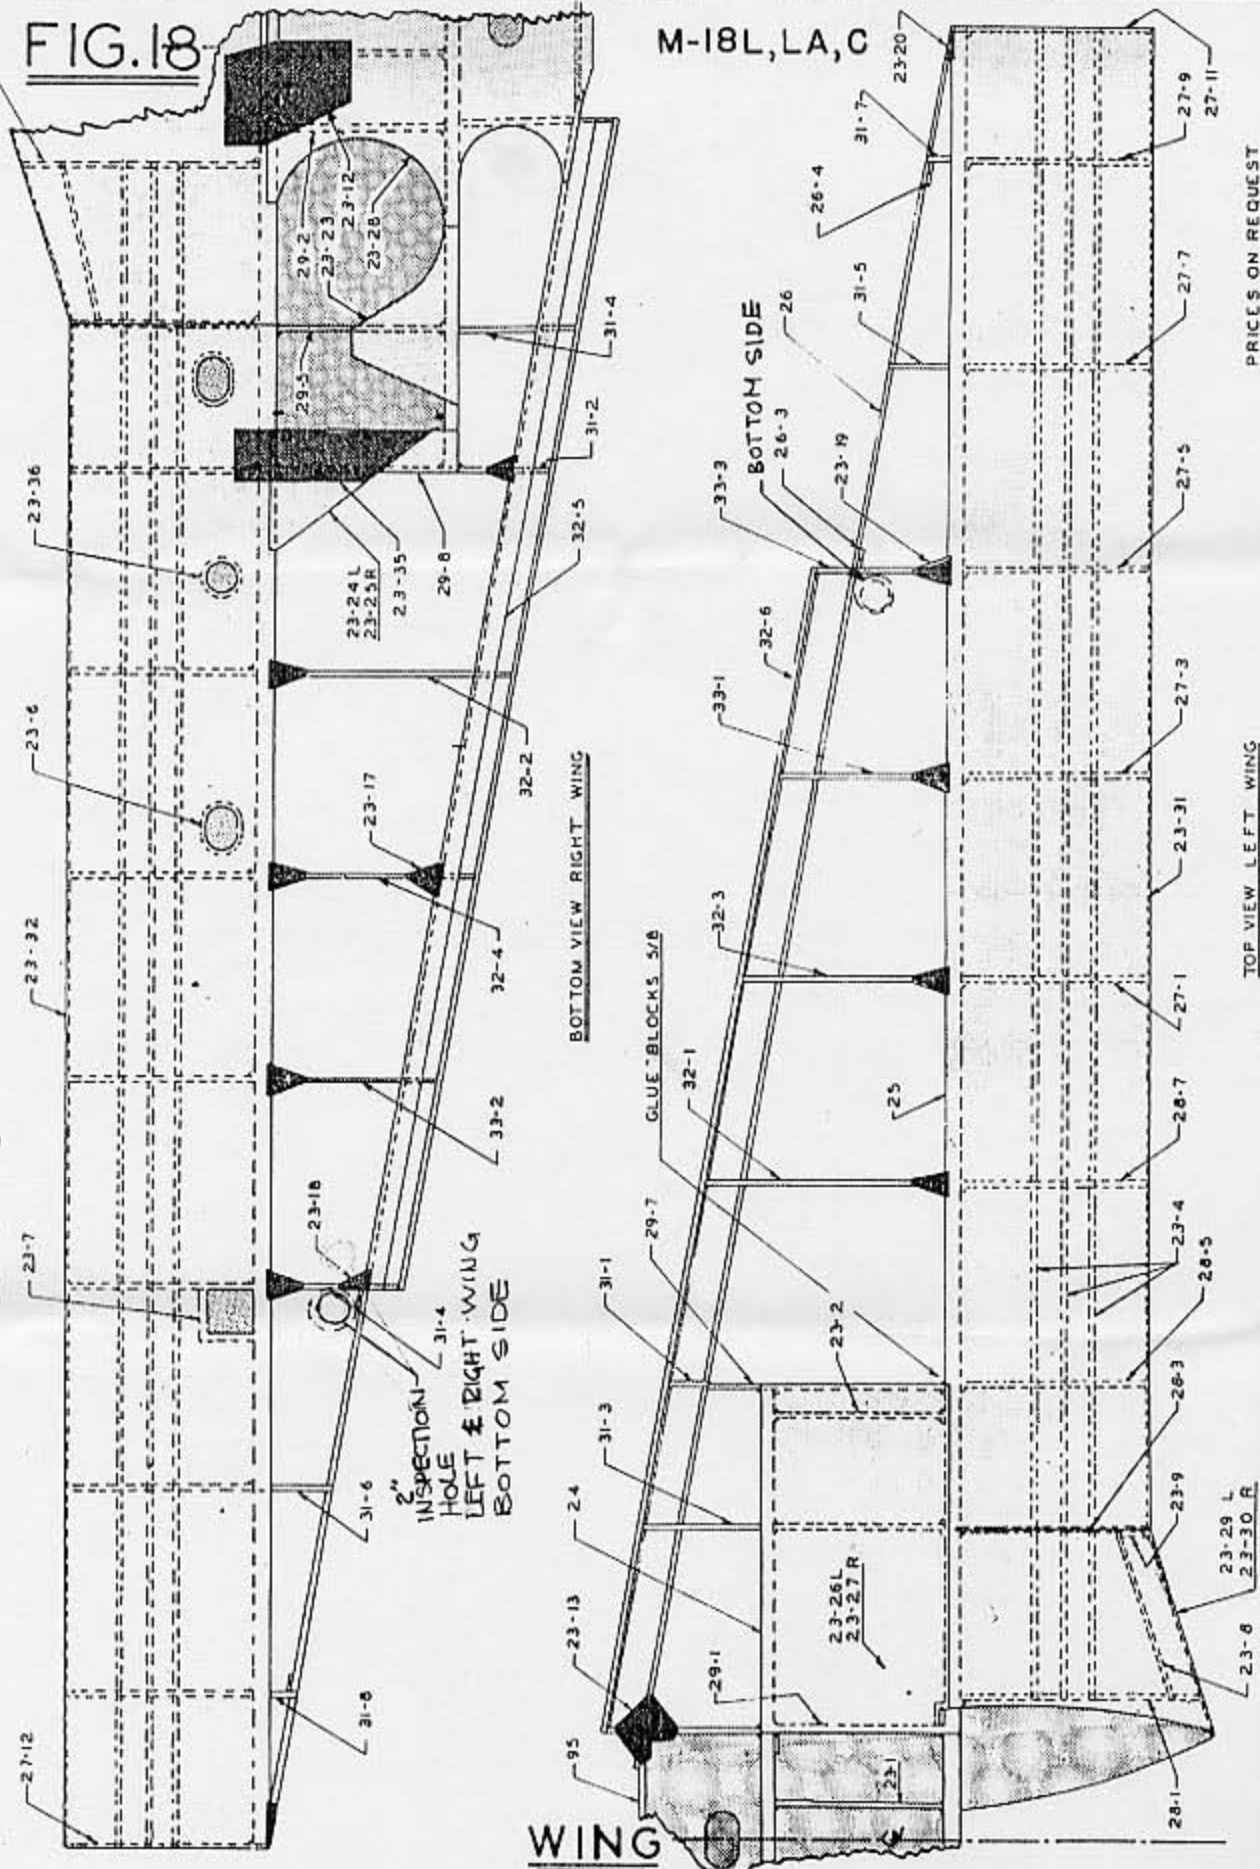
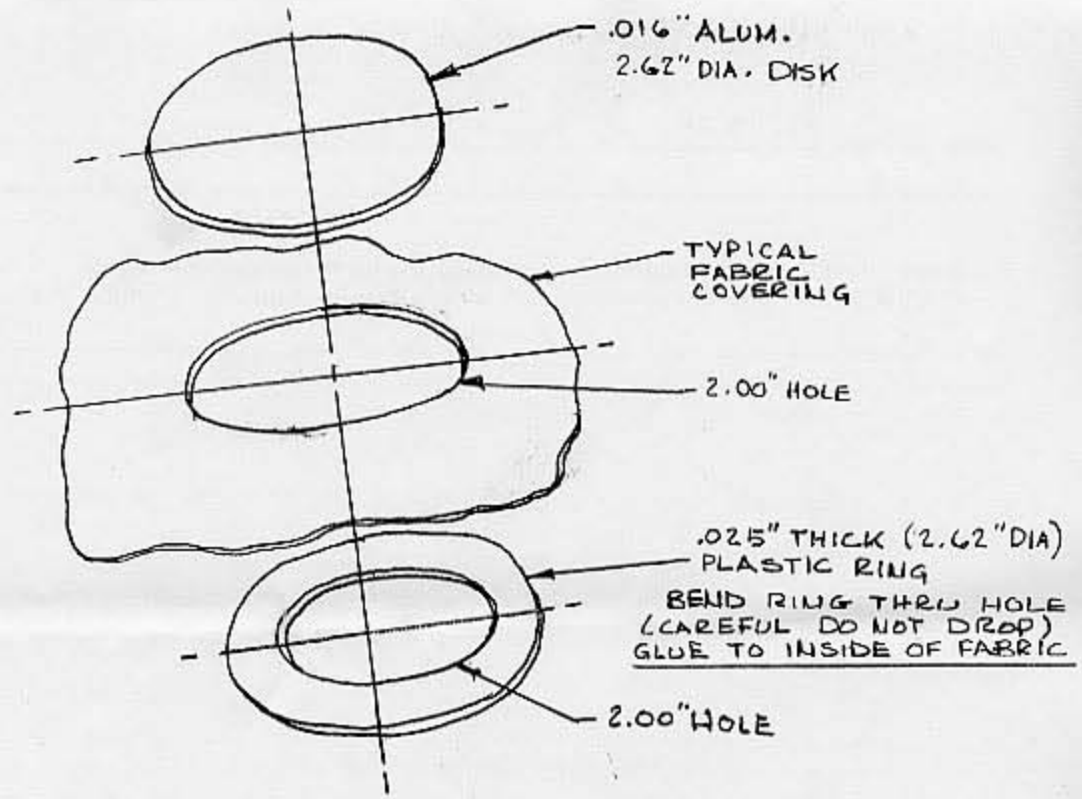
**FIG. 18**

- (4) Remove wing fabric locally in area of aileron hinges and at inboard corner of aileron cutout. Check condition of wood and glue joints. If evidence of deterioration is found, remove fabric further as necessary for complete examination of forward area of wing trailing edge. Check attachment of wing trailing edge in aileron area for looseness.

- (a) Cut 2.00 inch diameter holes in approximately the locations shown on the bottom side of the wing drawing.
- (b) Cut a 2.62 inch diameter plastic ring with a 2.00 inch diameter hole from a .025 inch thickness material.
- (c) Follow the same procedures (c) and (d) described for FIGURE17 stab & fin to complete the process.
