**U.S. Department of Transportation  
Federal Aviation Administration**

**Airworthiness Directive  
Revision**

79-11-05 R1 MOONEY: Amendment 39-3480 as amended by Amendment 39-4050. Applies to Mooney M-18L S/N's 2 and up, M-18C S/N's 201 and up, M-18LA S/N's 100 through 200, M-18C55 S/N's 323 and up certificated in all categories.

## COMPLIANCE OF AD79-11-05R1 FOR MOONEY MITES

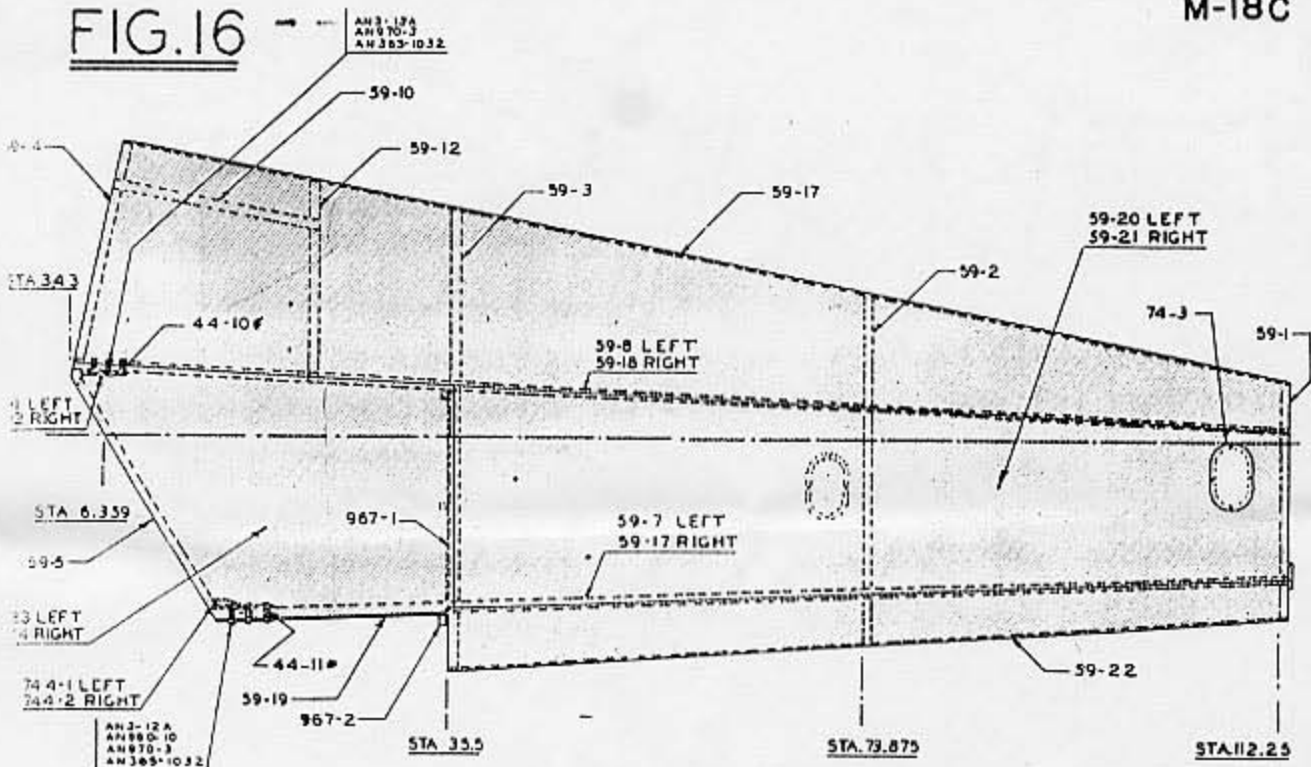
FIG. 16

- C. In order to accomplish the stab & fin modifications of inspection holes to accommodate the AD note, the stab & fin assembly should be removed from the fuselage. In addition, it is best to disassemble the stab & fin for access to cut certain inspection holes for inspection of possible spar cracks and wood deterioration.
